Maryland Inventory of Historic Properties number: WM: 13-57

MARYLAND INVENTORY OF HISTORIC BRIDGES  
HISTORIC BRIDGE INVENTORY  
MARYLAND STATE HIGHWAY ADMINISTRATION/  
MARYLAND HISTORICAL TRUST

SHA Bridge No. 15054 Bridge name MD 355 (Frederick Road) over Little Seneca Creek

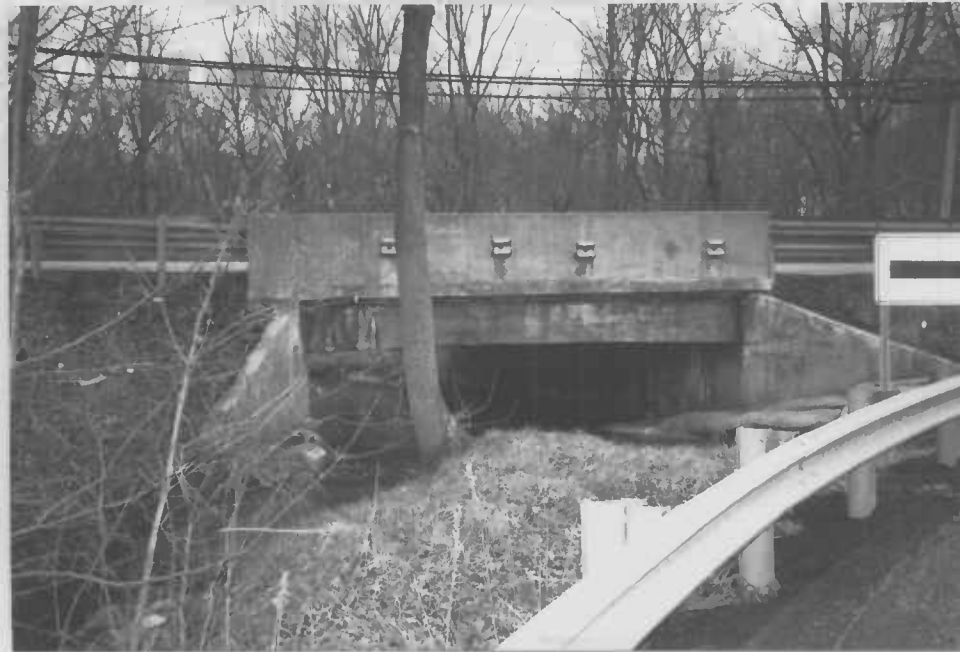
8. 3 OF 5

7. EAST ELEVATION

The bridge parapets walls were altered in the early 1990s. The east parapet was replaced with a solid concrete parapet. A portion of the original parapet remains on the west elevation. The east parapet has been topped by solid concrete to increase its height. The roadway side of the east parapet has been parged in concrete.

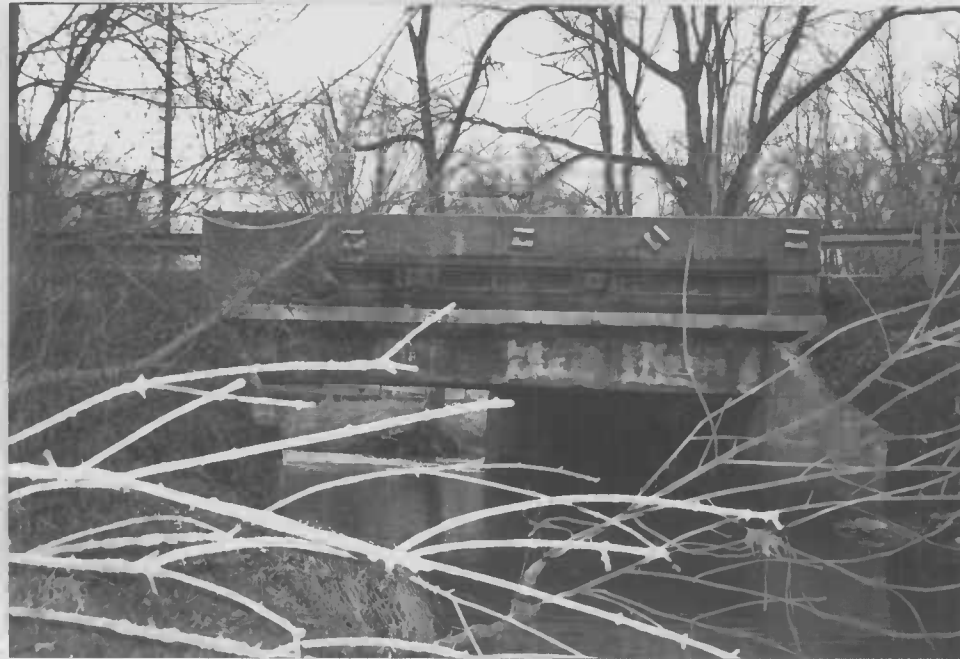
8. 4 of 5

7. WEST ELEVATION

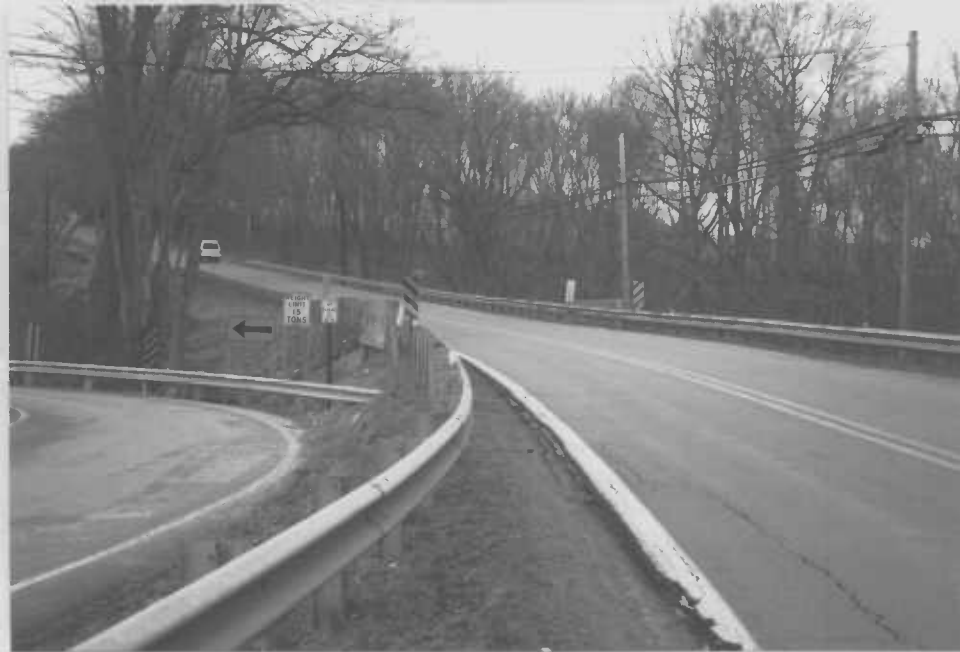
WEIGHT  
LIMIT  
15  
TONS

1. M 13-57
2. (15054) MD 355 OVER LITTLE SENECA CREEK
3. MONTGOMERY CO MD
4. TIM TAMBURINO
5. 3-97
6. MD SHPO
7. SOUTH APPROACH
8. 1 of 5

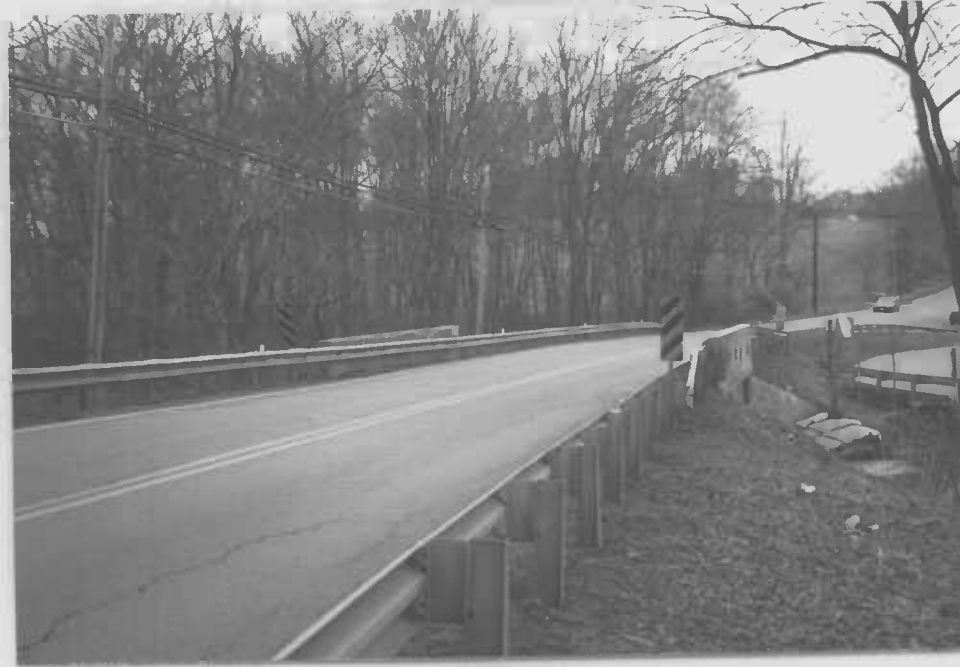
8. 2 of 5

7 NORTH APPROACH

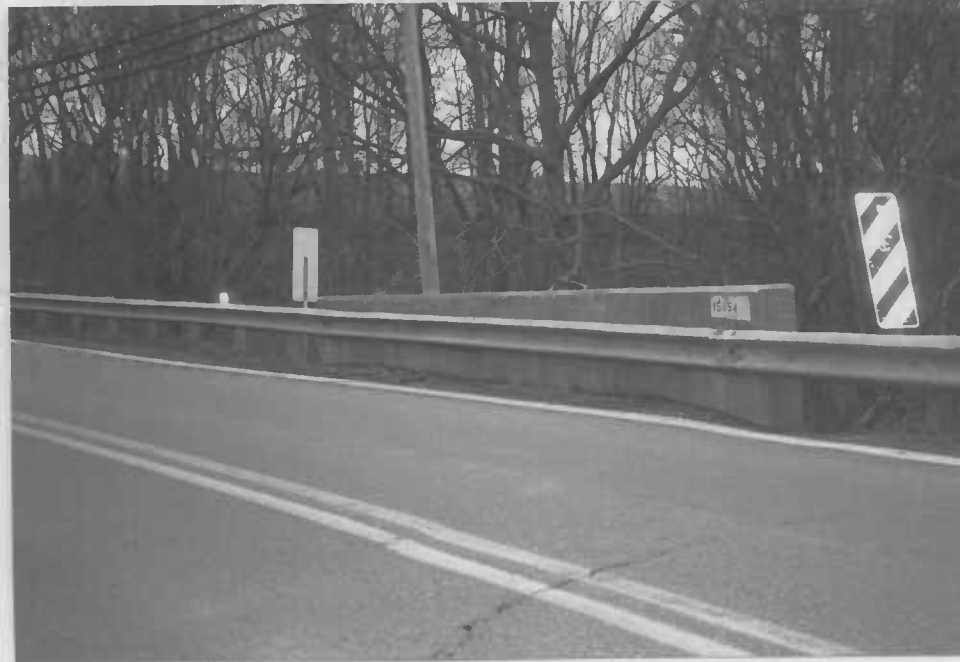
1. M 13-57
2. (15054) MD 355 OVER LITTLE SENECA CREEK
3. MONTGOMERY CO MD
4. TIM TAMBUKING
5. 3-97
6. MD SHPO
7. WEST PARAPET
8. 5 of 5
